NRL/MR/6180--98-8172

Full-Scale Submarine Ventilation Doctrine and Tactics Tests

June 30, 1998

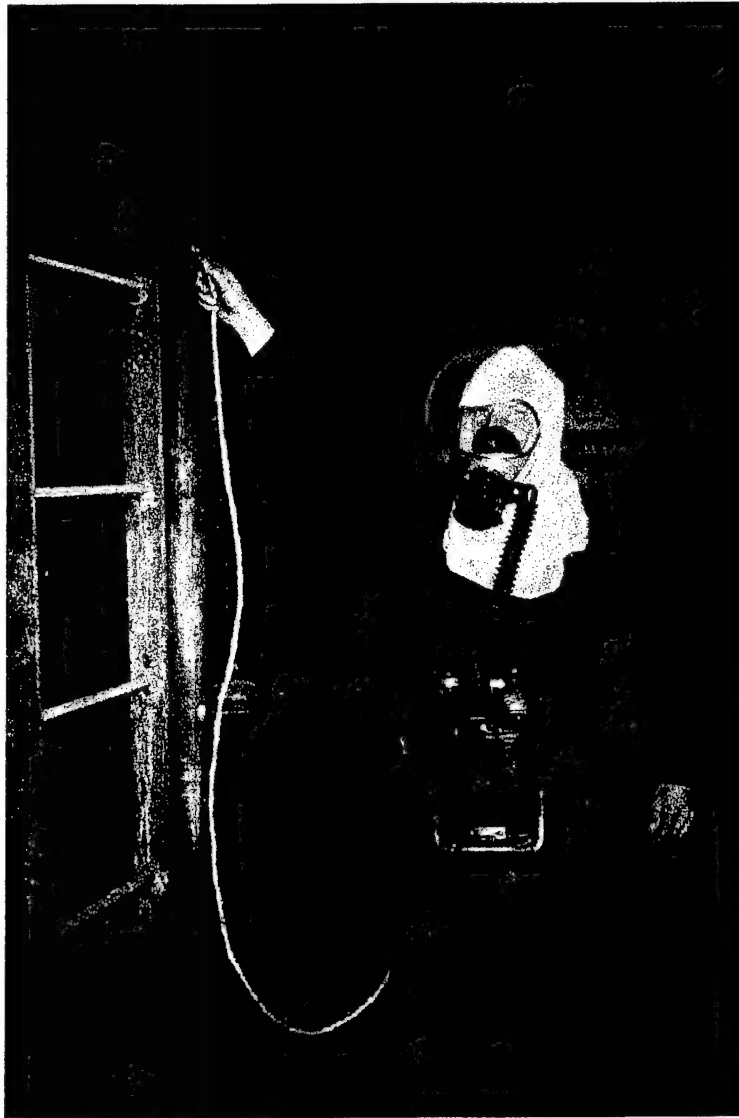
Fig. 3 — Simulated EAB with OBA and rope tether

The use of Emergency Air Breathing (EAB) apparatus is an integral part of submarine damage control doctrine. Piped, low pressure breathing air was not available for these tests. To simulate the use of an EAB, both SCBA's and OBA's were used to simulate EAB's. To simulate the breathing hose connecting the EAB mask to the EAB manifold and the restricted movement of the EAB wearer, an 2.44-m (8-ft) long piece of 0.6-cm (0.25-in.) diameter nylon rope with clips on both ends was used. The entire length of rope was wrapped with duct tape to make the rope less flexible to simulate the stiffness of the rubber hose. The two EAB masks with the 7.62-m (25-ft) long rubber hoses were also made available for use by the test personnel. Figure 3 shows the simulated EAB by the OBA and rope tether.
